Epson Stylus Photo 820 Teardown

Teardown of an Epson Stylus Photo 820 Inkjet Printer.

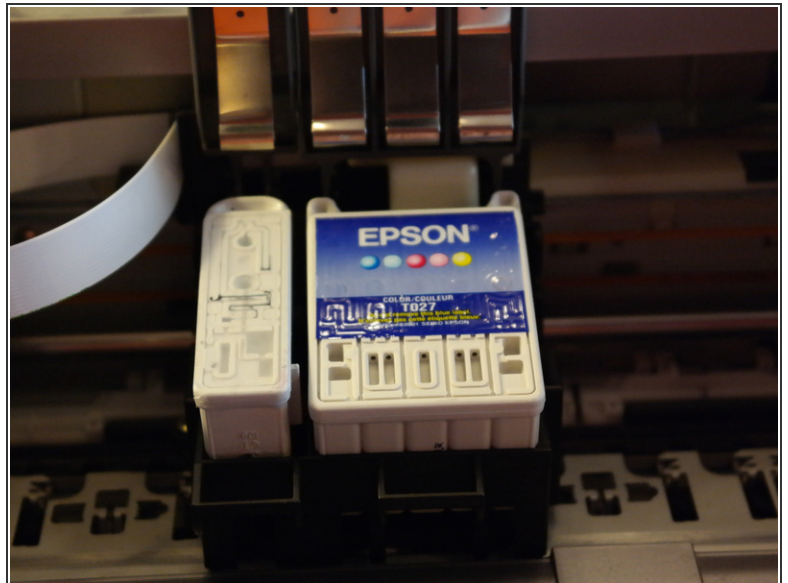
Step 2

- The ink cartridges are replaceable. That is a good sign.

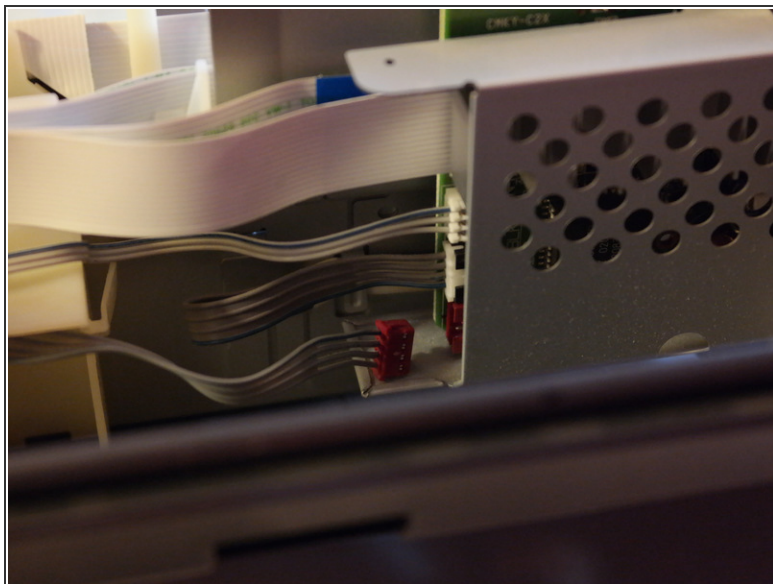
Step 10

- The stepper motor cable is routed through a series of plastic tabs that hold it down.
- It eventually connects to the (hidden) logic board.

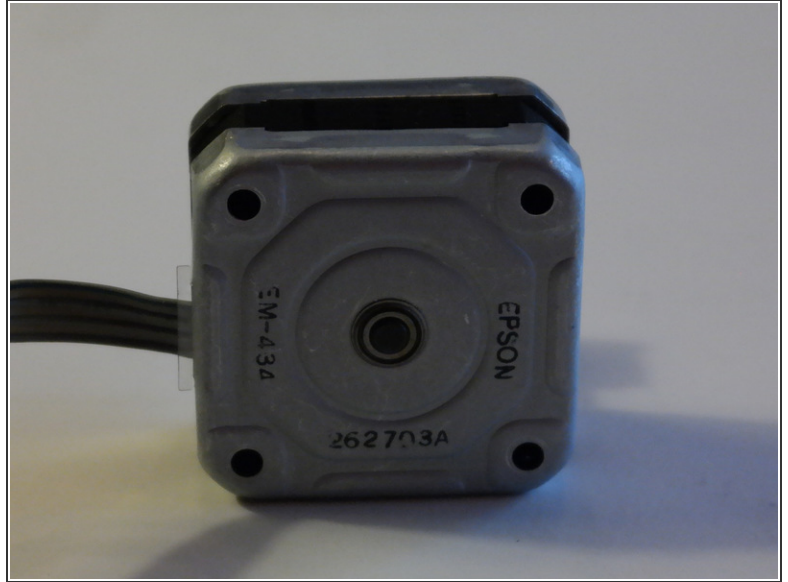
Step 11

- A closer look at the stepper motor.

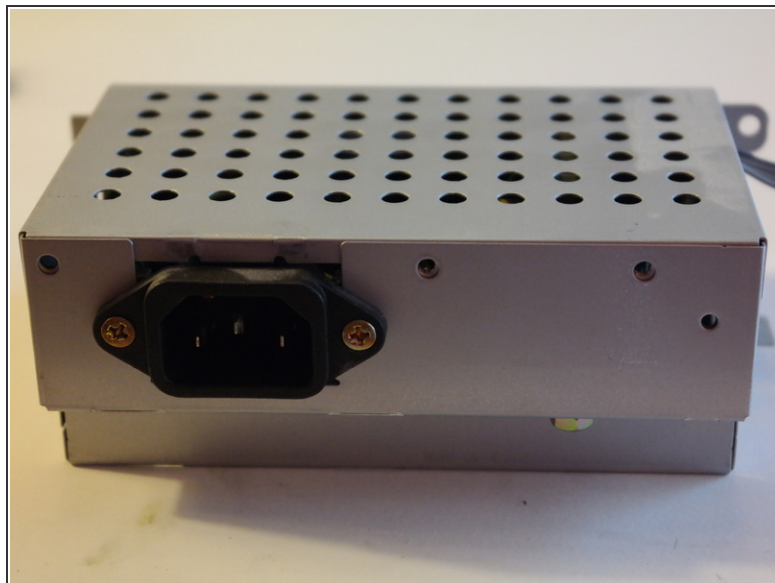
Step 17

- The power supply is connected to the main board by 4 surprisingly thin wires.

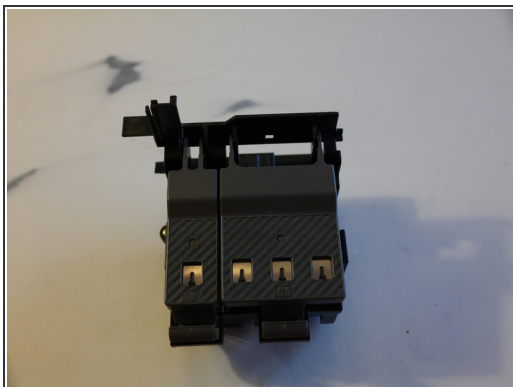
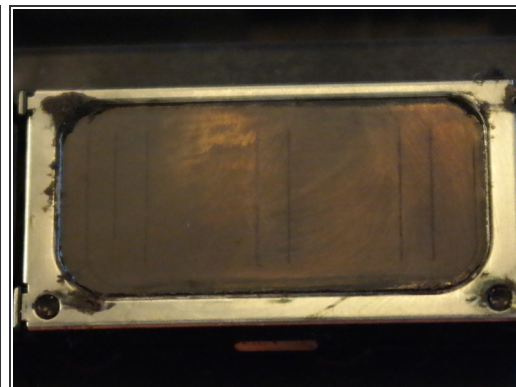
Step 27

- The print head
- The six lines on the print head visible in the second and third pictures are actually rows of microscopic ink nozzles.

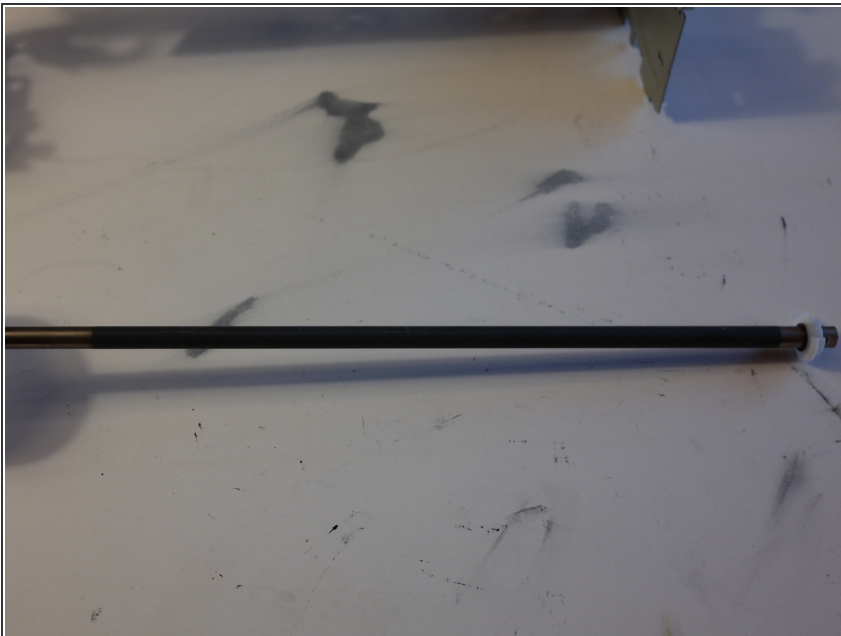
Step 40

- Another rod is removed from the printer.
- This rod is coated in something that helps it grip onto the paper better.

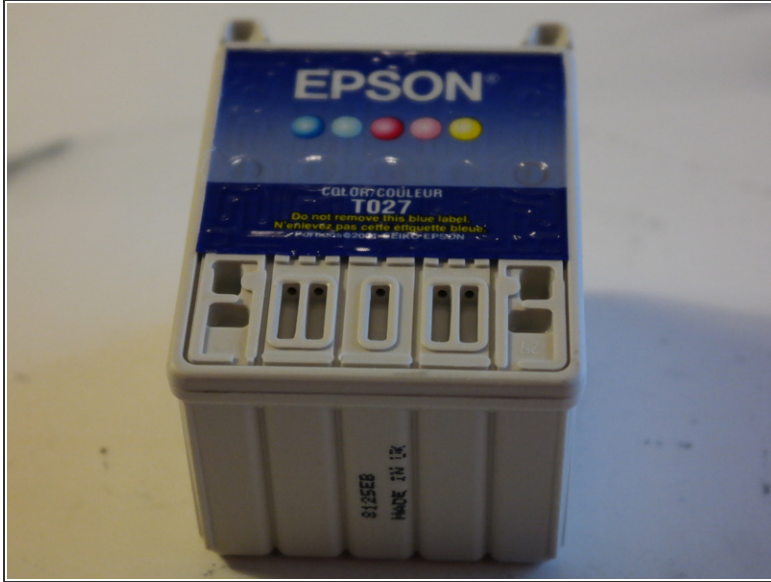
Step 43

- **Bonus Teardown Time!**
- Time to see what is underneath the 'Do not remove' sticker located on the ink cartridge.
- What is this network of labyrinthine passageways?
- The answer is a capillary tunnel to reduce ink pressure. The lower row of holes leads into the cartridge itself, while the top row leads to the ink nozzles.
